UNITED STATES
DEPARTMENT OF LABOR
MINE SAFETY AND HEALTH ADMINISTRATION
COAL MINE SAFETY AND HEALTH

REPORT OF INVESTIGATION
Surface Coal Mine
Fatal Powered Haulage Accident
July 14, 2012

Colowyo Mine
Colowyo Coal Company LP
Meeker, Moffat County, Colorado
Mine ID No. 05-02962

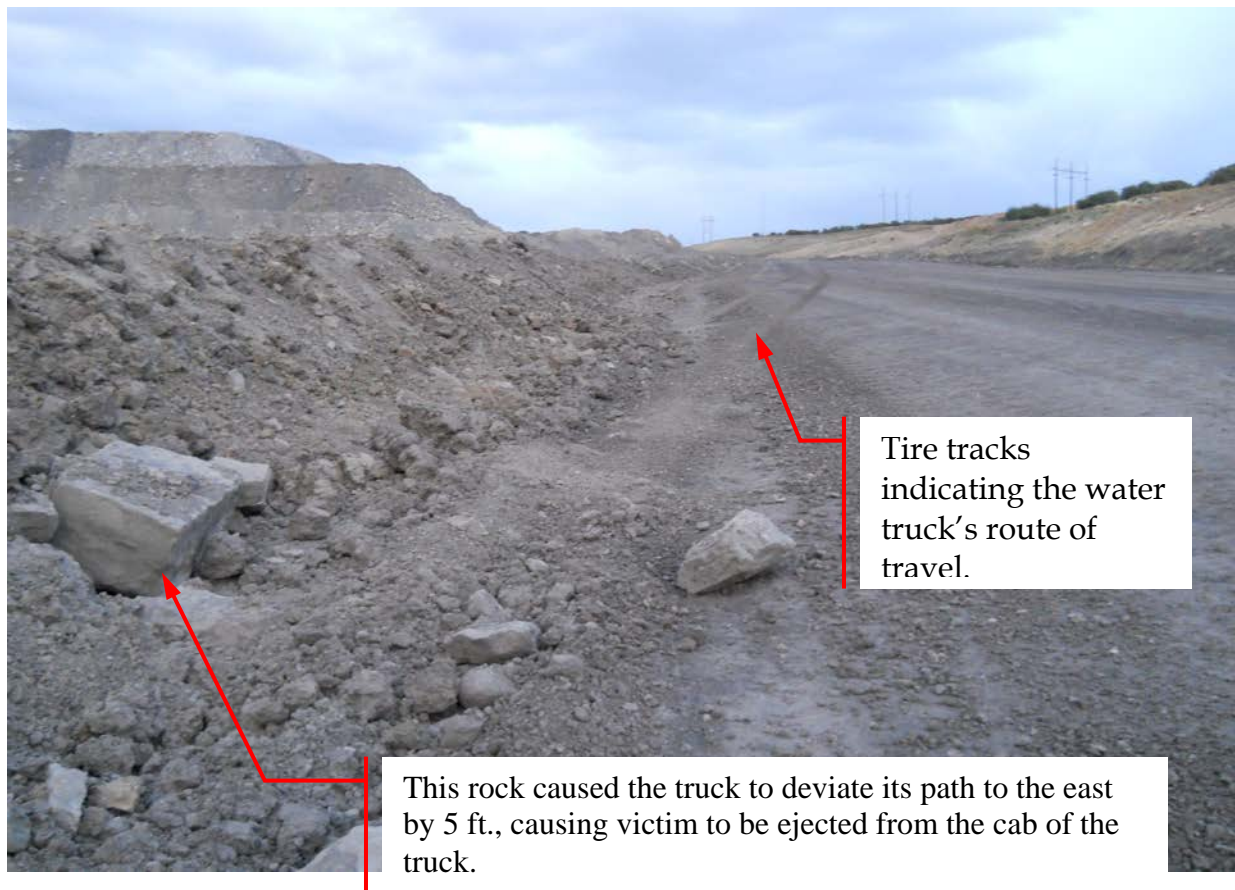
Figure 2: Site evidence of truck travel and cause of truck deviation.

At 5:40 p.m., Kawcak lost control of the water truck while ascending the haul road known as Ridge Road. The accident investigators believe that Kawcak shut off the truck because the "engine stop" was pulled when rescuers reached the truck. Moreover, investigators found that the truck was not running when it overturned. The truck lost power after being shut off. Ridge Road is a perimeter haul road, with a varying grade that averages 9.6 per cent. After losing power, Kawcak's water truck traveled backwards and downhill for 6 tenths of a mile, until the water truck contacted the berm along the east side of Ridge Road. Eighty-one feet after initial contact with the berm, the water truck struck a large rock, causing the water truck to deviate its path by five feet. Kawcak was ejected from the water truck. The water truck continued downhill, with the left side tires on top of the berm for 66 additional feet, until the truck dropped off the berm. Dropping off the berm caused Kawcak to be ejected from the water truck and run over with the right front tire of the water truck. The water truck continued downhill for another 300 feet, until it struck the west side slope, causing the truck to roll over and come to rest. Kawcak was not wearing a seatbelt during the accident.

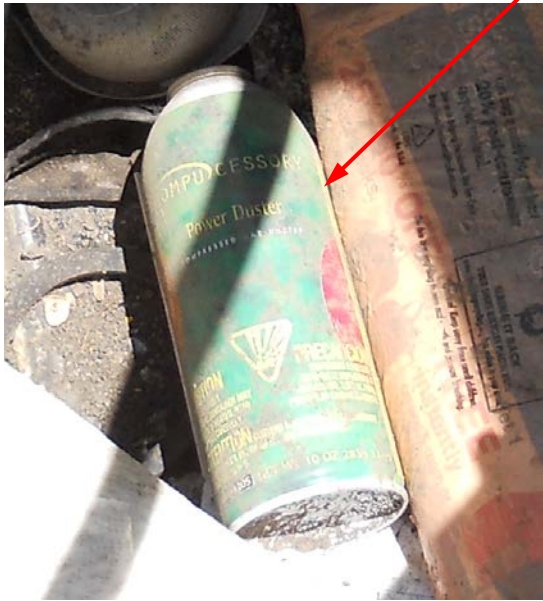
Figure 3: Can of 1,1- Difluoroethane found in vehicle.

An autopsy found the presence of the chemical 1,1-Diflouroethane in the victim's body, as a result of "Intentional Inhalation." The only source of this chemical present in the victim's water truck was a can of Compucessory Power Duster, which is a computer accessory. The chemical's material safety data sheet (MSDS) Section 2. states, the hazard of inhalation as "Excessive intentional inhalation may cause respiratory tract irritation and central nervous system effects (headache, dizziness). Vapors may cause dizziness or suffocation." MSDS Section 7. Handling and Storage, lists the directions for safe handling as "Avoid breathing mists or aerosols of this product. Use good industrial hygiene practices in handling this material." The MSDS Section 8., Exposure Controls/Personal Protection, has these items listed; Engineering controls, "Use only under good ventilation conditions or with respiratory protection." Respiratory protection, "Where exposure guideline levels may be exceeded, use an approved NIOSH respirator." The can of Compucessory Power Duster was the only source of the chemical 1,1-Diflouroethane present in the cab of the water truck.

The 1,1-Diflouroethane can showed no punctures or damage, which could have caused a discharge from the can. Accidental inhalation, such as from an unplanned discharge from the can, would be very unlikely as 1,1-Diflouroethane is heavier than air and would have settled toward the floor of the cab, near the victim's feet. The truck's air conditioner selector levers were set to intake fresh air into the cab, which could have diluted the concentration of 1,1-Diflouroethane.

Corrective Action: The mine was required to provide specific training on the use of any hazardous chemical present at this mine, as per the Hazardous Communication Plan in effect at the mine. The miners were trained in the hazards of 1,1-Diflouroethane.
