***Generator Interconnection  
System Impact Study Report***

***PJM Generation Interconnection Request  
Queue Position #AA2-116***

***Cook-East Elkhart 345 kV***

**June 2016**

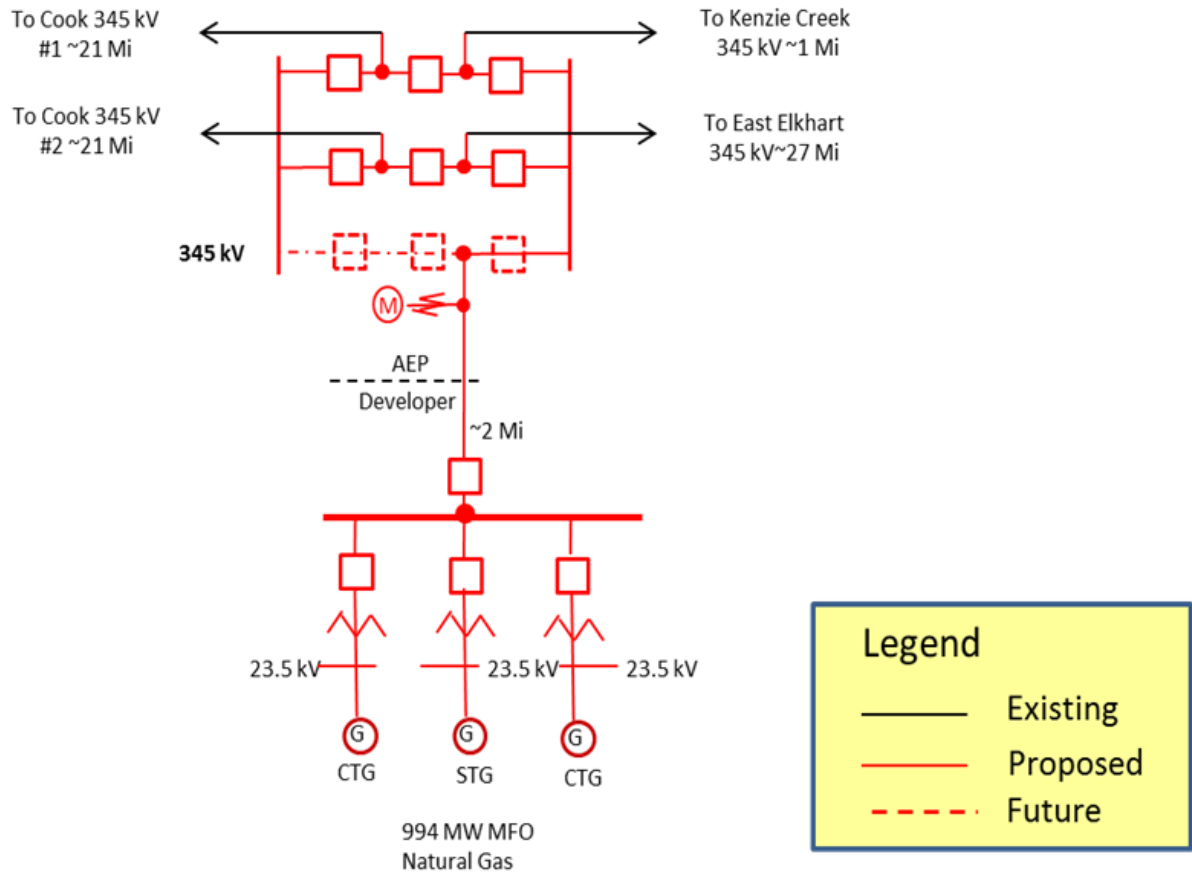
**Figure 1 – PJM Queue # AA2-116 Cook-East Elekhart 345 kV Switching Station ( Just West of Kenzie Creek 345 kV Station)**

A new in-line 345 kV switching station will be constructed approximately 1 mile west from the existing Kenzie Creek 345/138 kV substation in Cass County, Michigan. This new station will tie together the Cook – Kenzie Creek 345-kV circuit section and the Cook – East Elkhart 345-kV circuit section as shown in Figure 1. The new switching station is to consist of six (6) 345 kV circuit breakers physically configured to provide for future expansion to a breaker and half bus arrangement, but initially operated as a ring-bus (Figure 1). The station will also include 345 kV metering, SCADA, and associated equipment. Protection relays in the surrounding area will need to be upgraded to accommodate the addition of the new generating station.

**The following work is required to connect PJM Project AA2-116 as shown in Figure 1**
